LiDAR QA/QC
- Quantitative and Qualitative Assessment Report -

USGS Somerset County, NJ, LiDAR
May 15, 2008

Submitted to:
U.S. Geological Survey

Prepared by:
  **Dewberry**[®]
Fairfax, VA

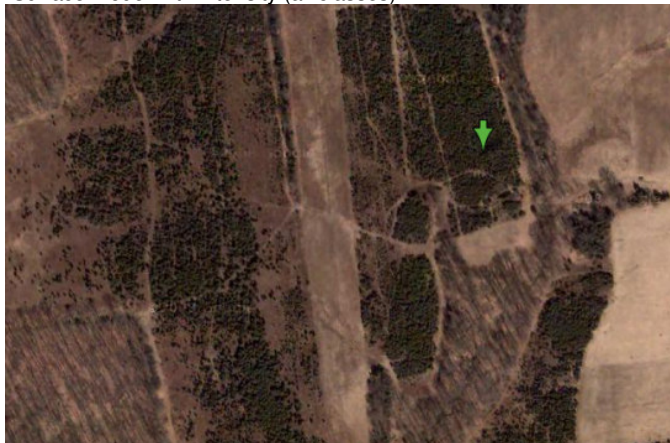
Figure 10 – 18TWK2897: poor Lidar penetration in dense vegetation (coniferous forest)

A problem that we often found is patches with lower density of ground points. When the vegetation is very dense, the LiDAR may not penetrate the canopy all the way to the ground, therefore only a few ground points remain after classification of the vegetation. Nevertheless, as soon as a few points are present, a 3D model can be built with an acceptable reliability, especially in flat areas. However, the definition of the surface is often of poorer quality; this is illustrated in Figure 10. This especially occurs in coniferous forest.

Bare-earth (class 2) model with density information (red = no points)

Surface model with intensity (all classes)

Ortho Photo in leaf off condition: the arrow point is in a coniferous forest

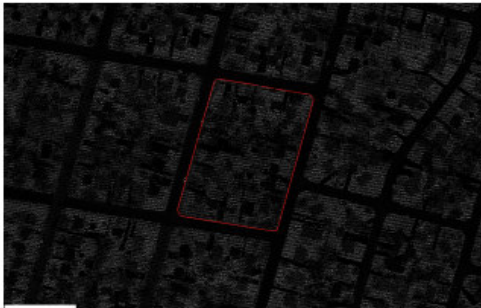
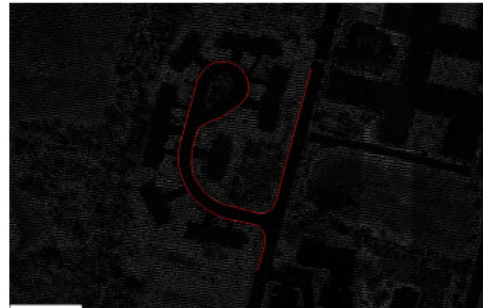
Horizontal accuracy checks

Using these aerial orthophotos, analysts digitized road intersections and other objects easily seen in the LiDAR intensity in 2 locations in each tile. The vector lines were then overlaid on the masspoints displayed with the intensity. Screen shots of the overlay are available in Appendix C.

By visual interpretation we were able to determine that the LiDAR points match the orthophoto, which comforts our judgment that the horizontal accuracy shall meet 0.5-m

Validation of the Lidar masspoints with intensity against vector lines digitized on orthophoto:
